First Step Home Inspections, Inc.

6229 Tryon Road

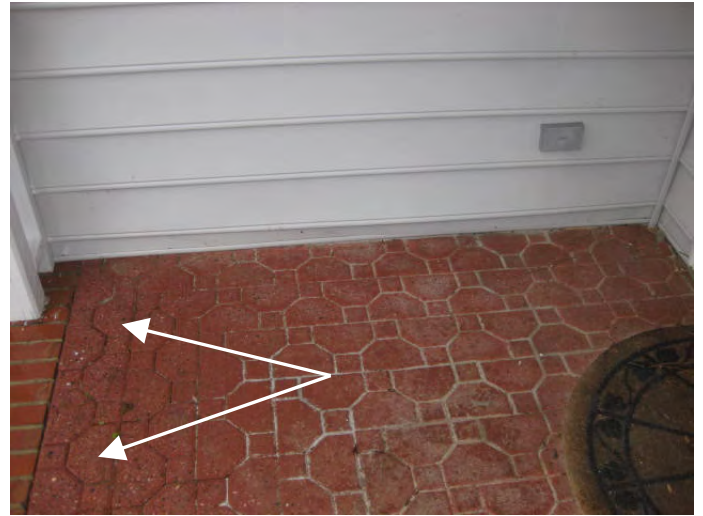
Front porch masonry pavers has several joints that are missing the mortar

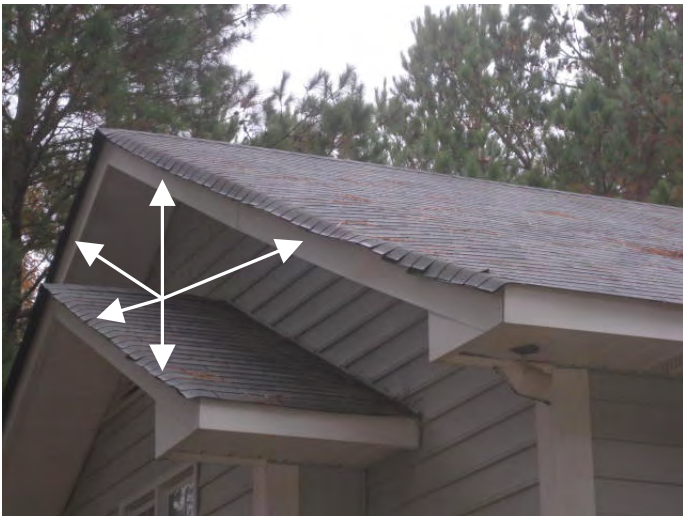
Most areas of the gable roof shingles extend too far beyond the rake edges

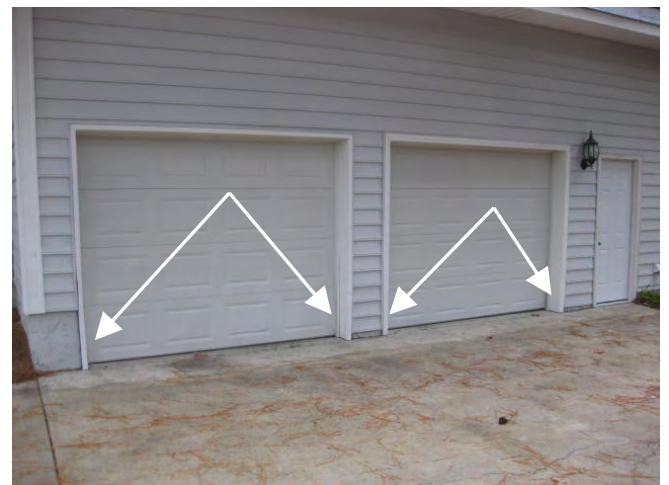
Garage right side vehicle door opening doorjamb aluminum cladding is damaged near the bottom

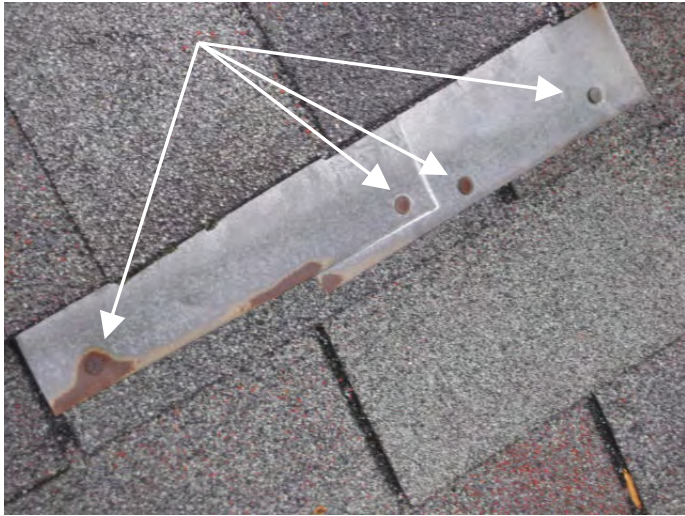
Roof flashing face nail heads are missing the roof sealant, visible from the roof

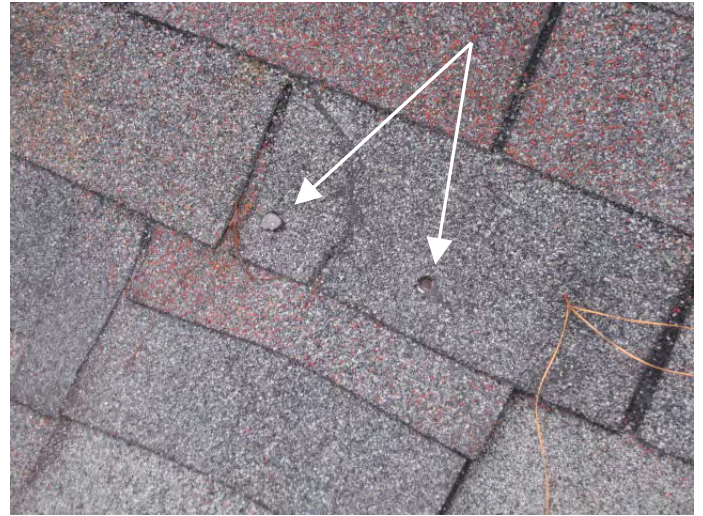
Roof ridge cap termination shingles face nail heads are missing the roof sealant

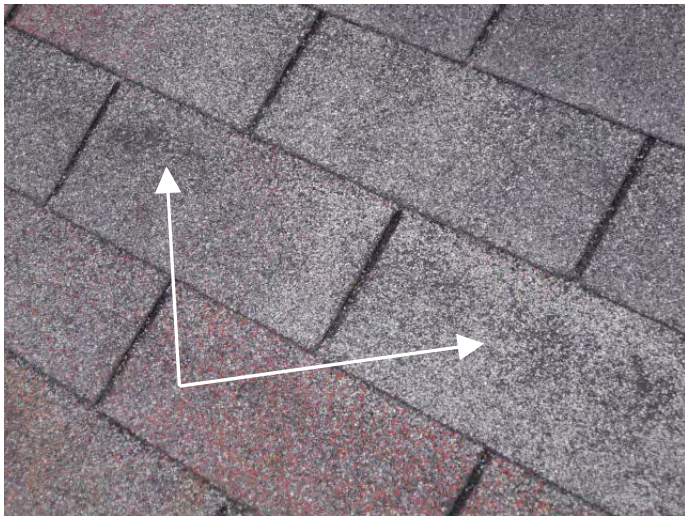
Roof shingles show evidence of wear

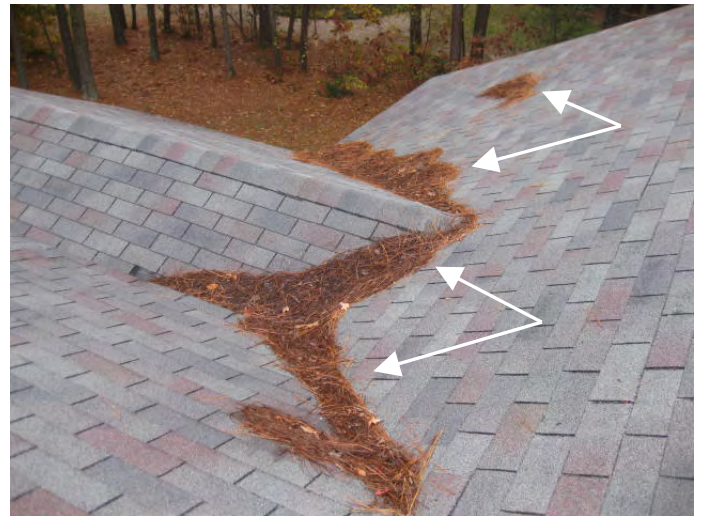
Tree debris present on roof shingles blocks visibility of shingles in some of the valley areas

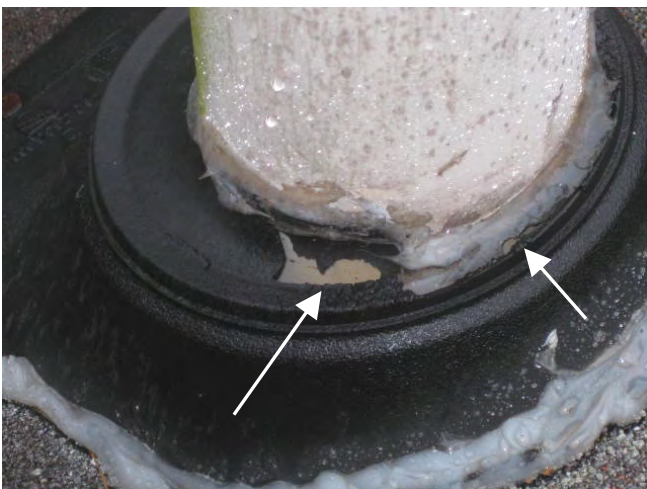
Both plumbing vent pipe roof penetration flashings (boots) are damaged, visible from the roof

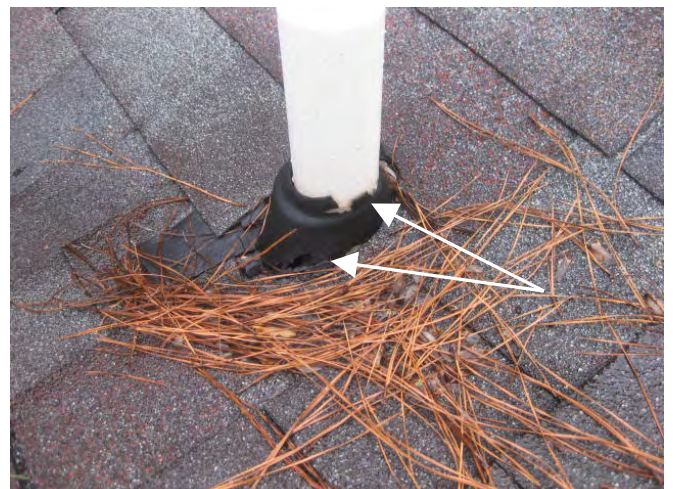
Both plumbing vent pipe roof penetration flashings (boots) are damaged, visible from the roof

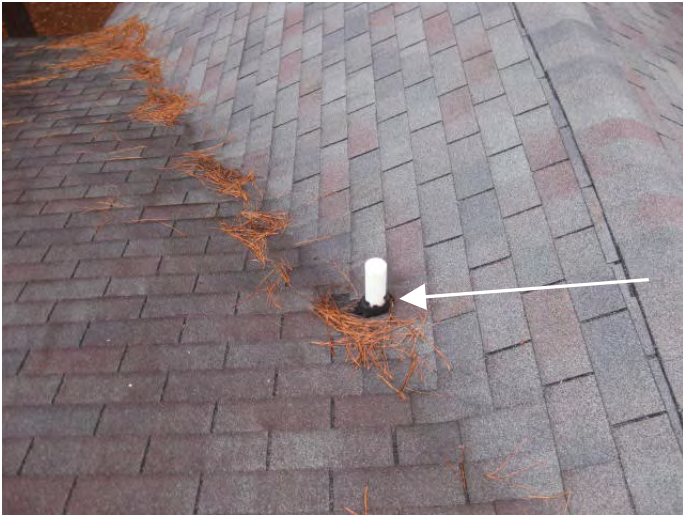
One plumbing vent pipe is currently located in a valley area

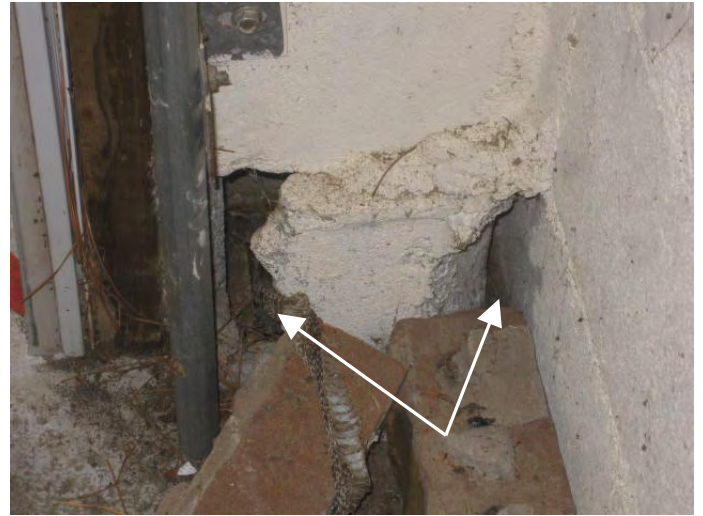
Garage right side front masonry wall lower concrete block is damaged, visible from inside the garage

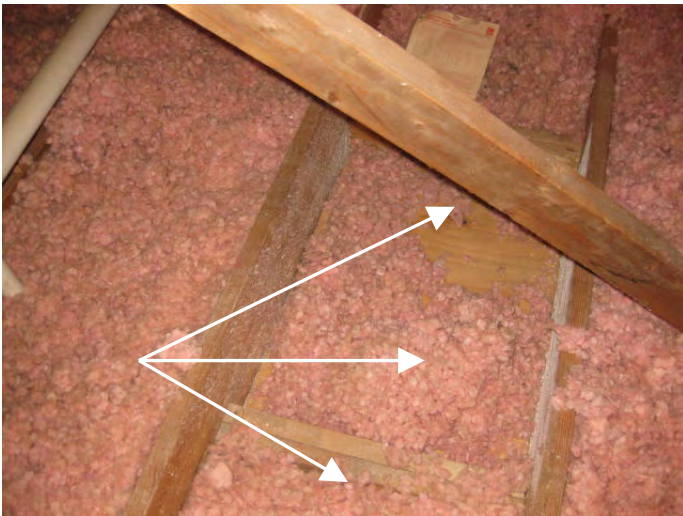
Attic scuttle hole cover panels are not properly insulated, visible in the attic (scuttle above the master commode room)

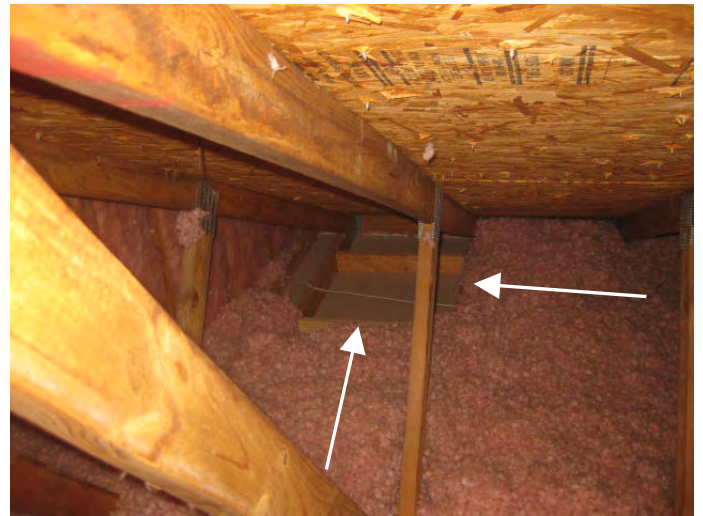
One section of the front left living room ceiling is missing the insulation along the foyer side, visible in the attic

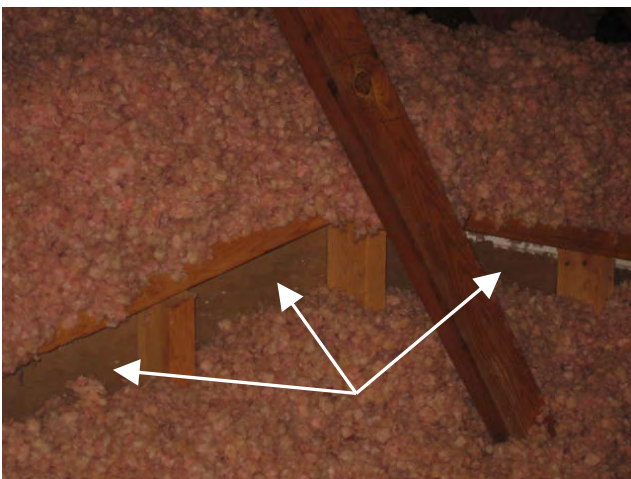
Great room right side upper wall is not completely or properly insulated, visible in the attic

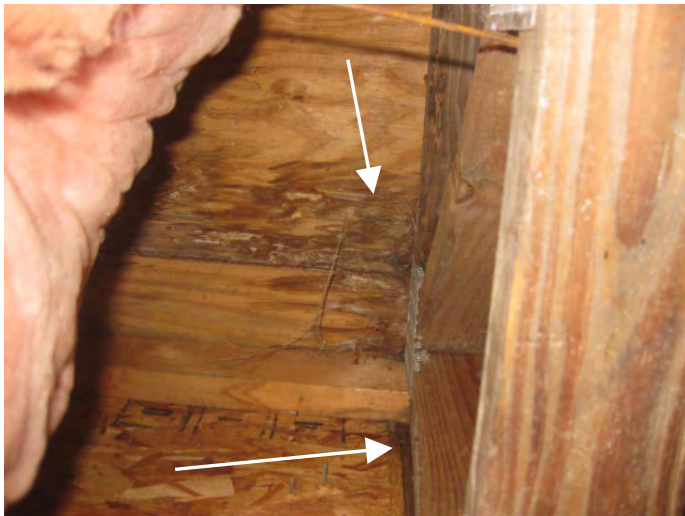
Floor framing is moisture stained below the master bathroom shower area, visible in the crawl space

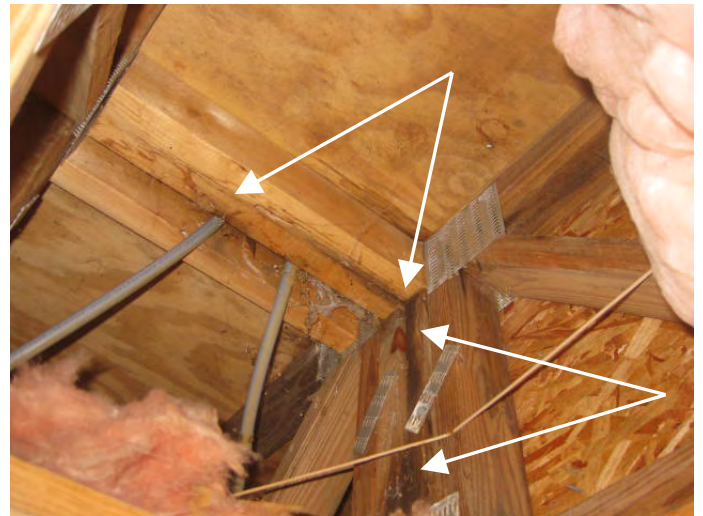
Floor framing is moisture stained below the master bathroom shower area, visible in the crawl space

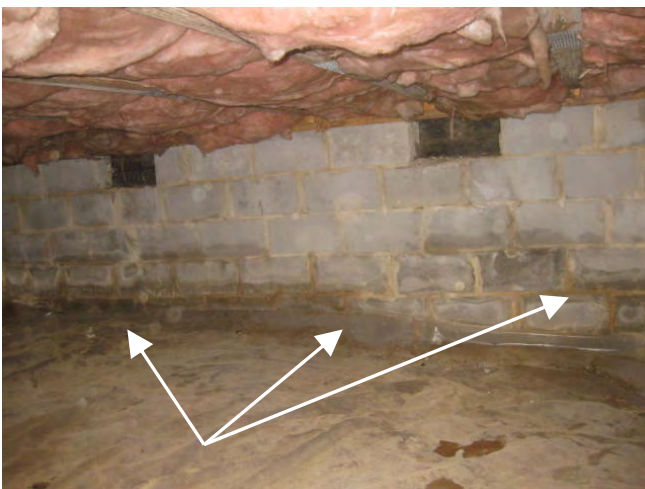
Front masonry foundation wall shows evidence of moisture penetration, located along the dining room front wall area

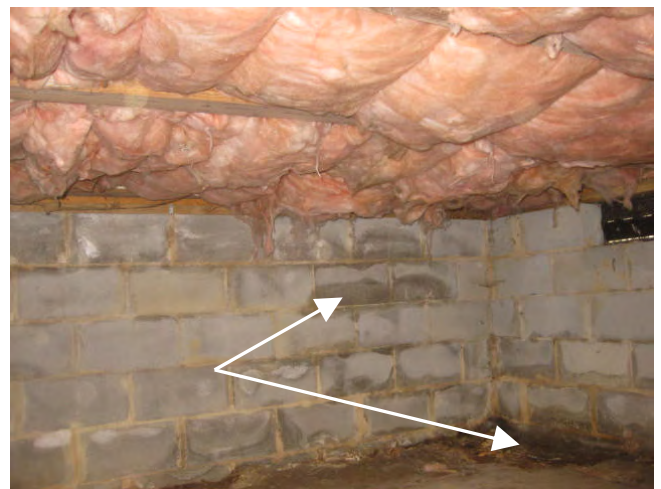
Front masonry foundation wall shows evidence of moisture penetration, located along the front left living room front and right side wall area

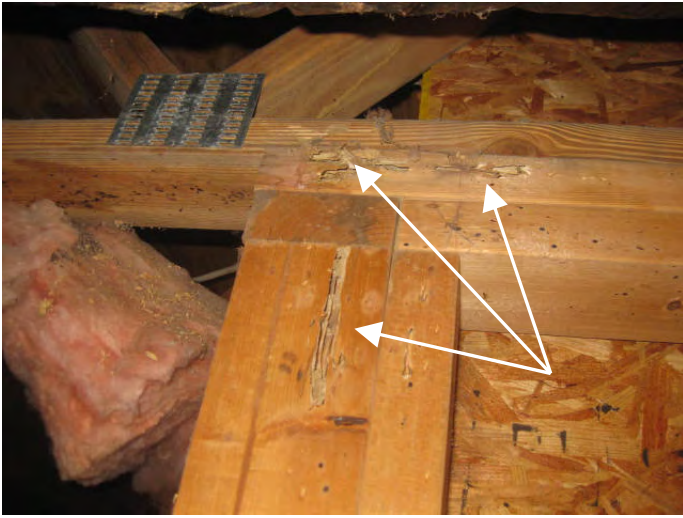
Floor framing shows evidence of wood destroying insect activity and damage, located at the left side of the dinette area, visible in the crawl space

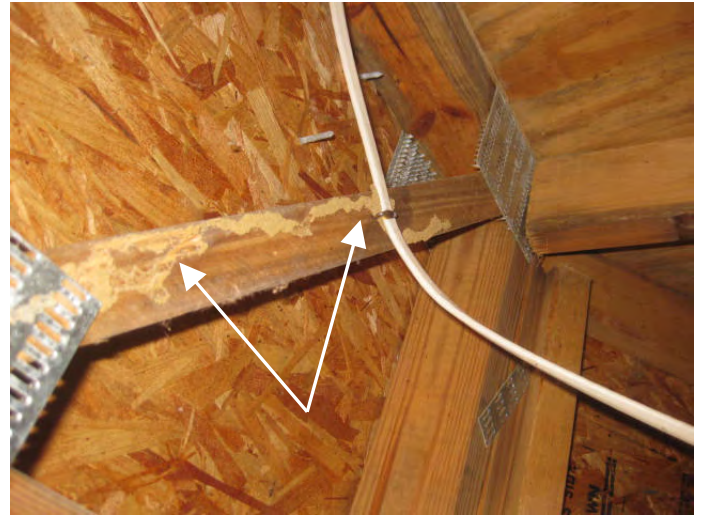
Floor framing shows evidence of wood destroying insect activity and damage, located at the left side of the dinette area, visible in the crawl space

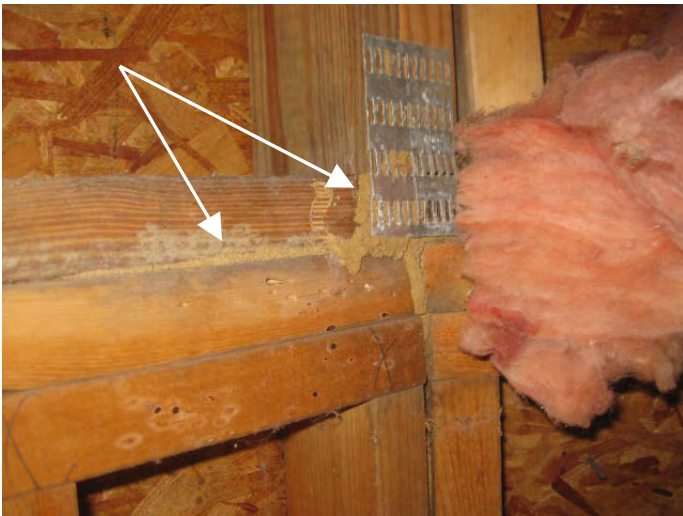
Floor framing shows evidence of wood destroying insect activity and damage, located at the left side of the dinette area, visible in the crawl space

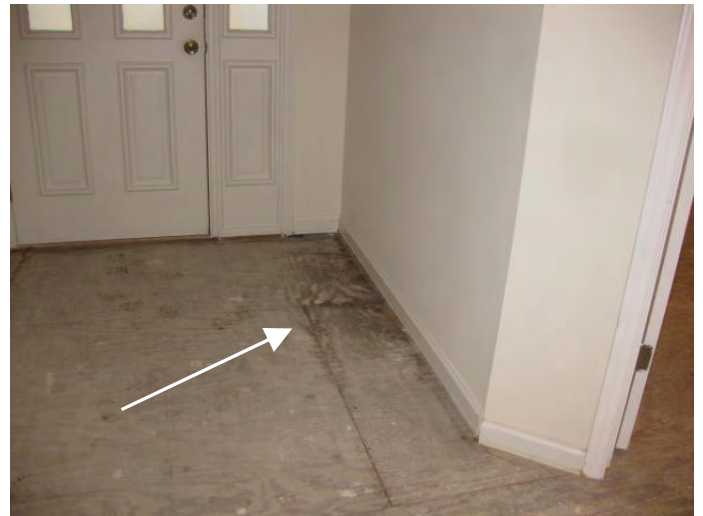
Front foyer floor sheathing is moisture stained and tests as having a slightly higher moisture content in the stained area

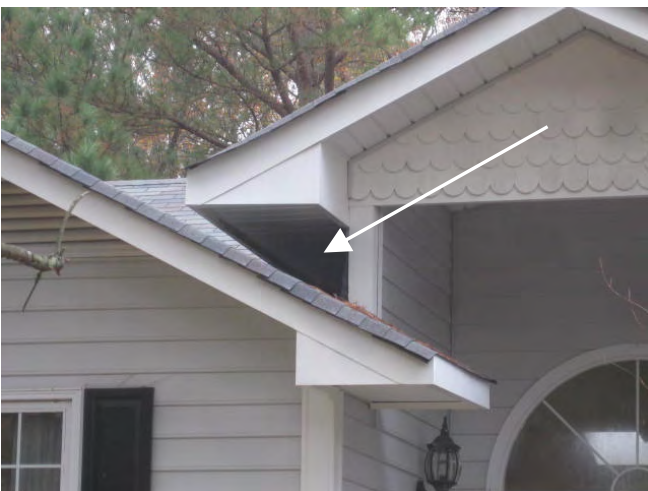
Front roof construction detail creates a high possibility of rainwater leakage

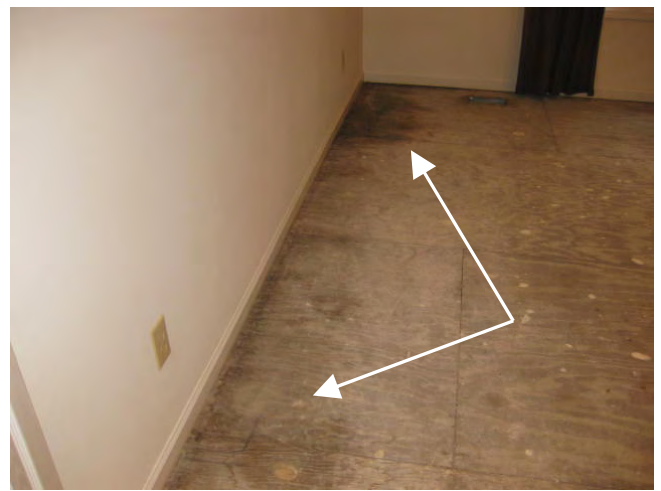
Front left living room floor sheathing is moisture stained and tests as having a slightly higher moisture content in the stained area

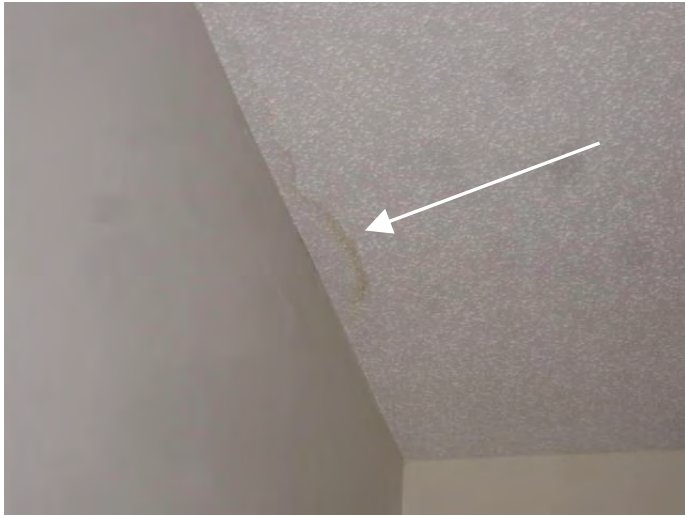
Front left living room ceiling is moisture stained near the front right corner

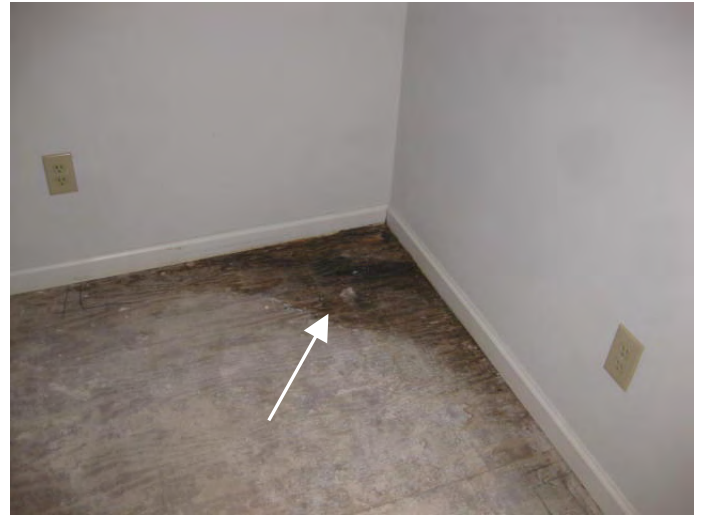
Master bedroom floor sheathing is moisture stained and tests as having a slightly moisture content in the stained area

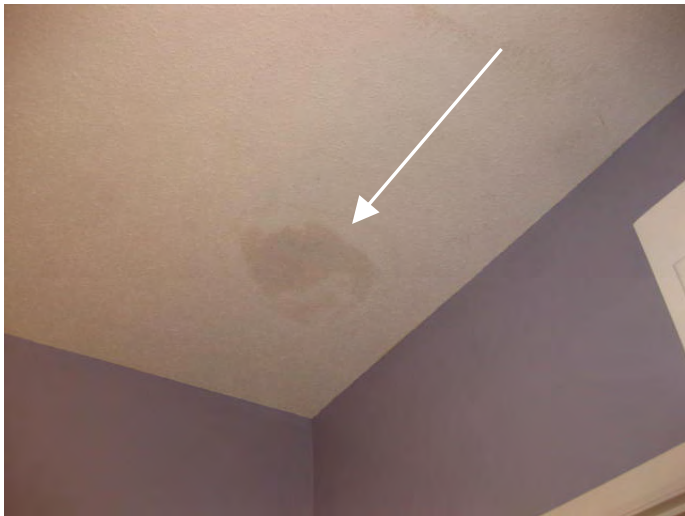
Master bathroom ceiling is moisture stained near the rear right corner (below the damaged plumbing vent pipe boot)

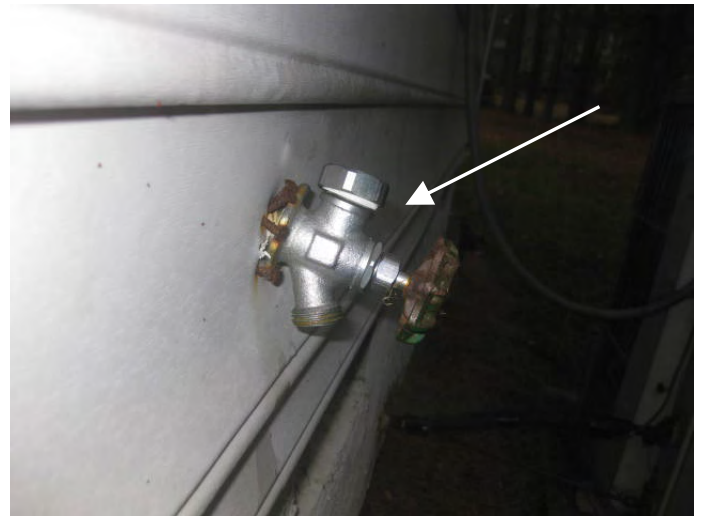
Left side exterior water faucet is excessively angled and not tightly secured to the wall

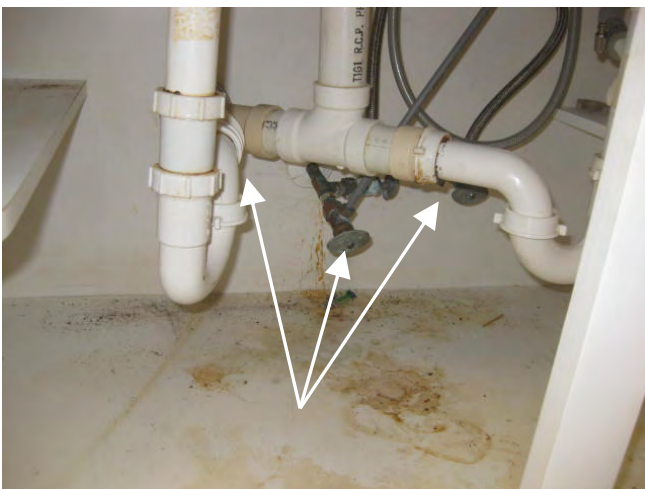
Kitchen sink drain pipes are leaking, and the water faucet hot water supply pipe shut off valve is leaking

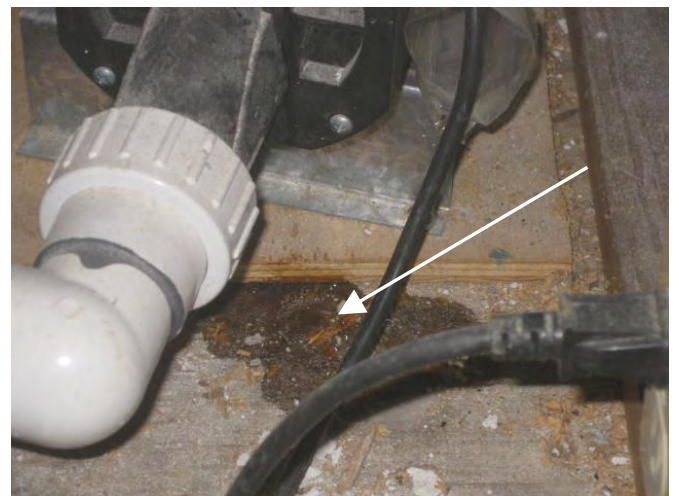
Master bathroom whirlpool tub circulation pump is leaking

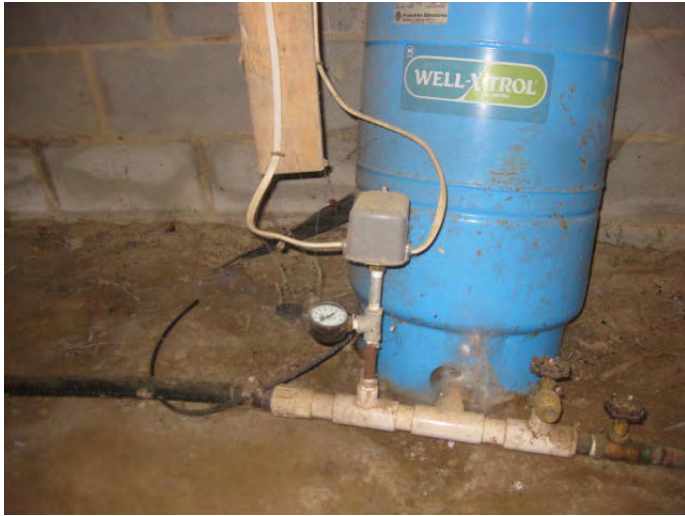
Well pump short cycles during water use

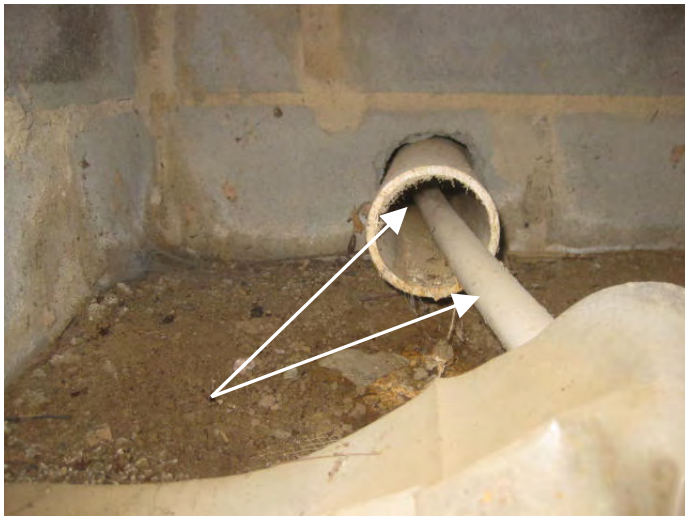
A/c primary condensate drain pipe is currently routed the foundation positive drain pipe, which looks to be clogged

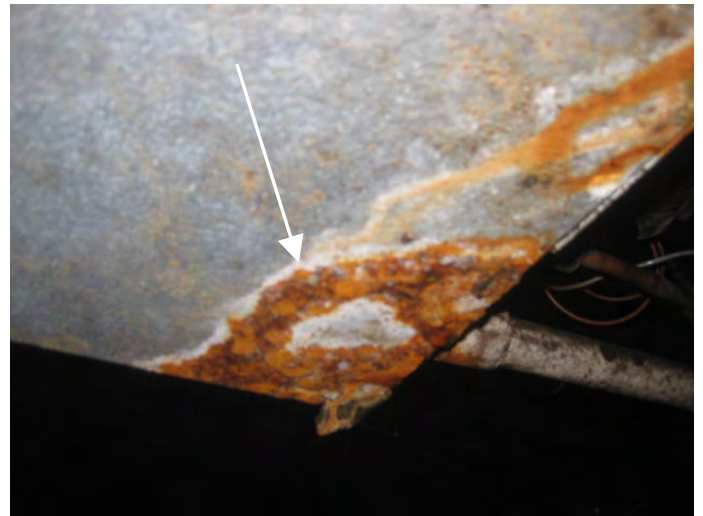
A/c indoor coil metal case is rusted (bottom view)

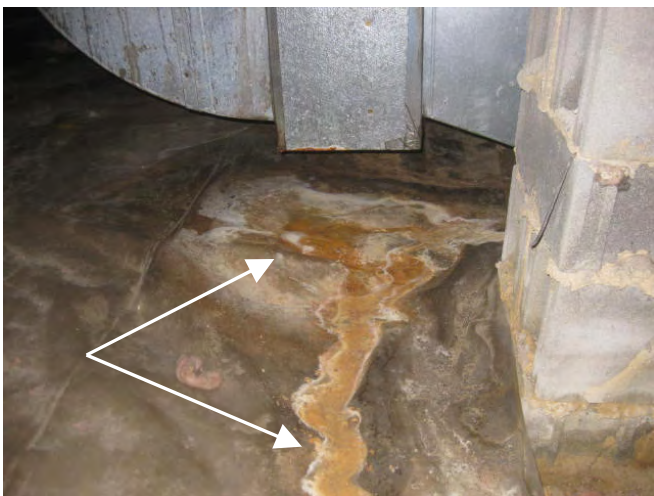
Crawl space vapor barrier is rust stained below the a/c indoor coil metal case (right side view)

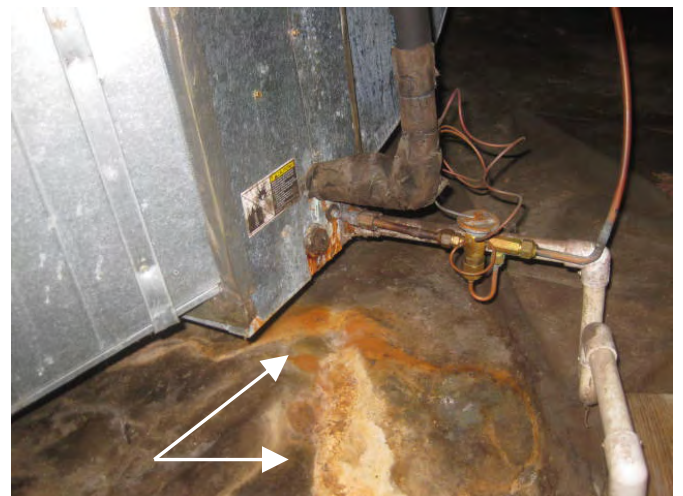
Crawl space vapor barrier is rust stained below the a/c indoor coil metal case (left side view)
